# CASE HISTORY

*SAFEBASE™ STANDARD DUTY HELICAL PIERS AND  
SAFEBASE™ 3.5# POLYURETHANE*

## HELICAL PIERS, TIEBACKS AND CONCRETE LIFTING

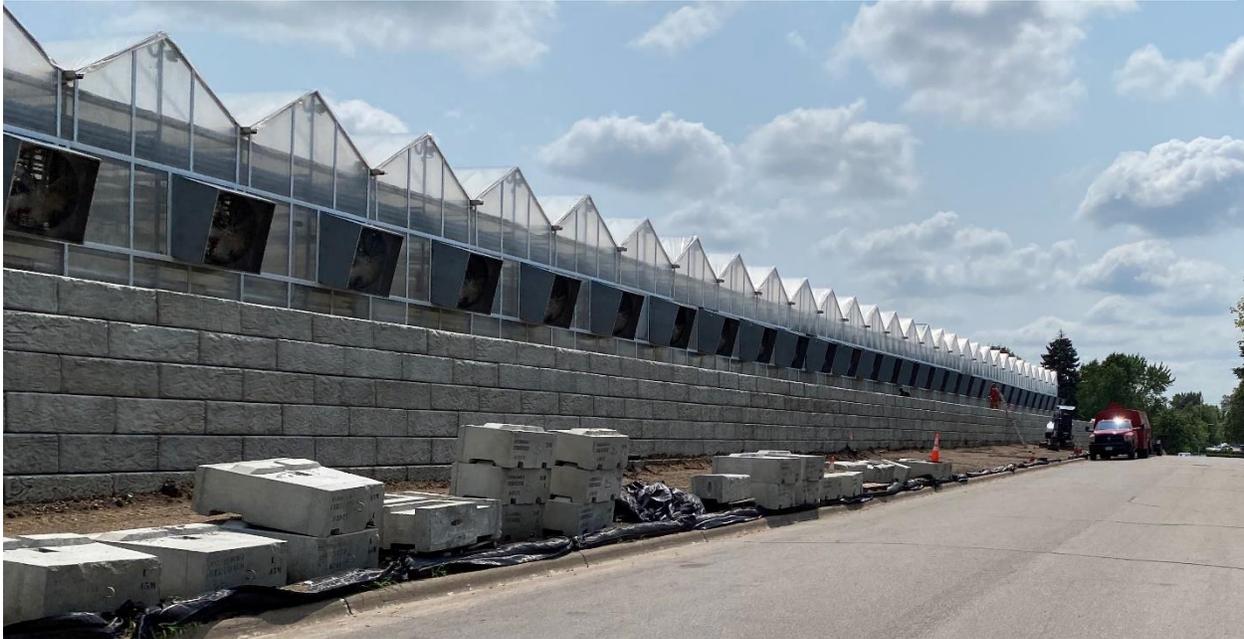
SafeBasements of Minnesota was contacted regarding several issues with the foundation at the Wagner Greenhouse in Minneapolis. A large portion of the foundation walls were tipping outwards and settling. Some of the concrete on the interior was also sloping downwards towards the foundation wall, exacerbating the issues by causing water from the green house to flow away from the drains and erode soil out from near the wall. A plan was made to install helical piers beneath a portion of the foundation that was settling and helical tiebacks on the portions of the foundation walls that were tipping outwards. After the piers were installed, the slab on the interior was to be lifted and brought back to the proper slope using SafeBase™ polyurethane foam jacking.

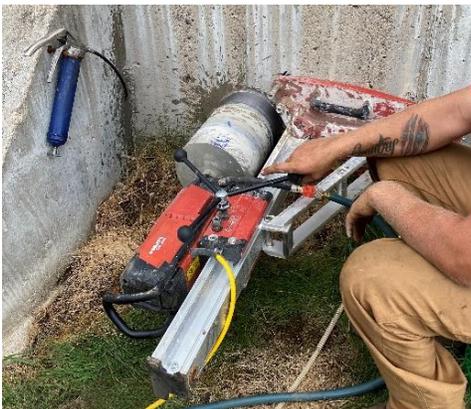
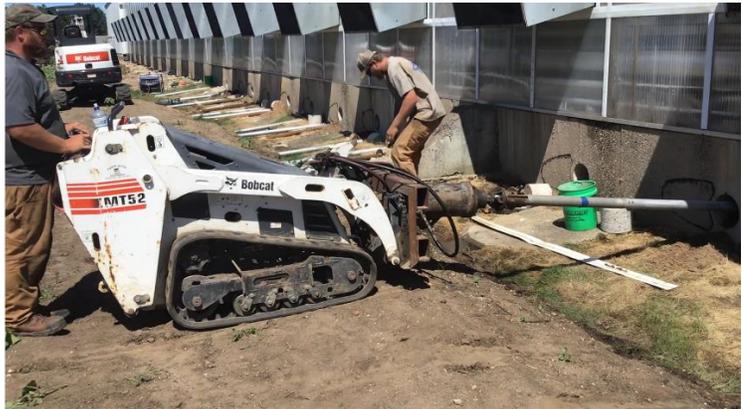
A total of 62 Helical Tiebacks were installed. First, 10" holes were core drilled into the face of the wall, then helicals were screwed in through the wall to the specified torque. After the helicals were installed a tieback adapter was attached to the pier shaft with threaded rod extending out beyond the wall. The hole in the wall was patched and plates were installed on the exterior.

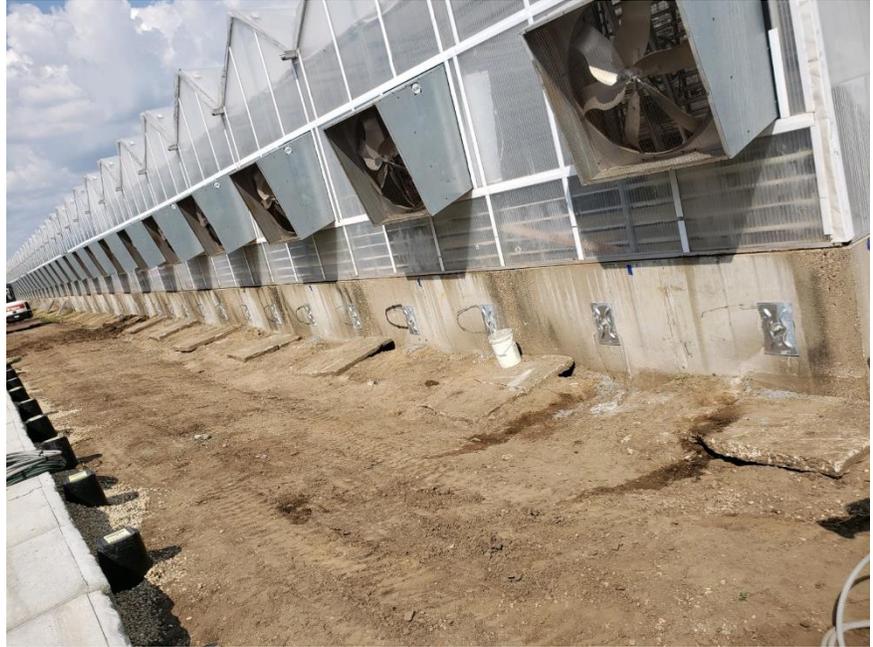
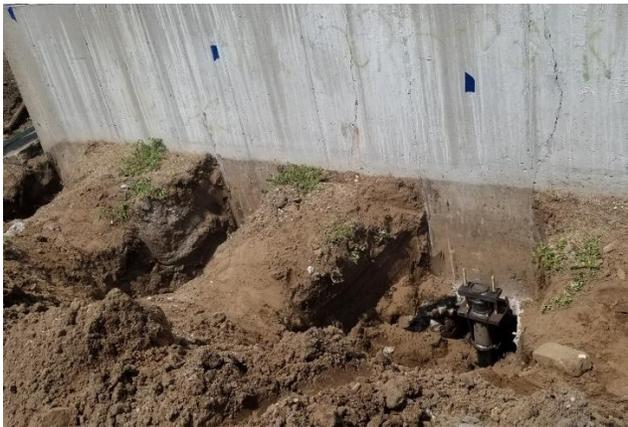
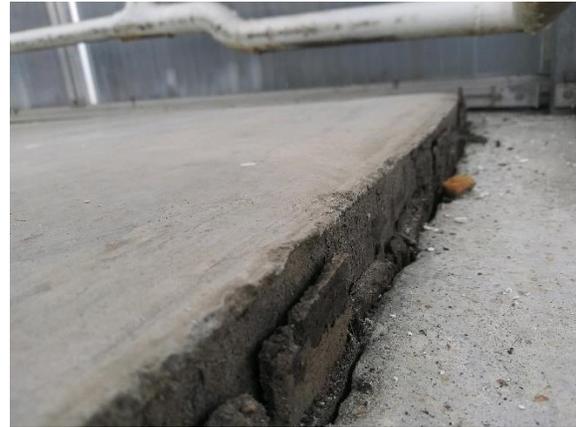
22 SafeBase™ Helical Piers were installed along the footing on a settling portion of the foundation. SafeBase™ SaberTooth™ pier brackets were installed beneath to footing attached to the helical piers to prevent further settlement. 1,992 pounds of SafeBase™ 3.5# Polyurethane foam was then injected beneath the slab on the interior to lift and level the floor and provide proper drainage. The project was completed in September of 2021.
