# CASE HISTORY

## HELICAL SLAB PIERS, POLYURETHANE VOID FILLING AND SAFETRACK WATERPROOFING - ITHACA, NY

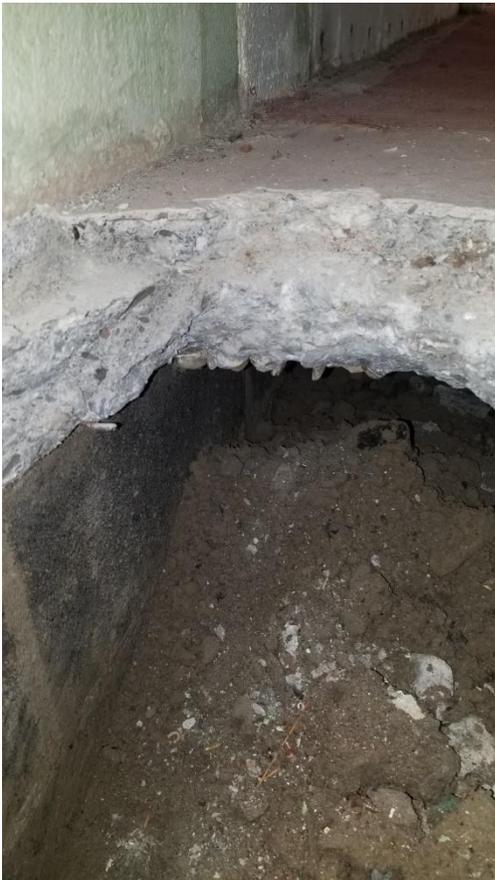
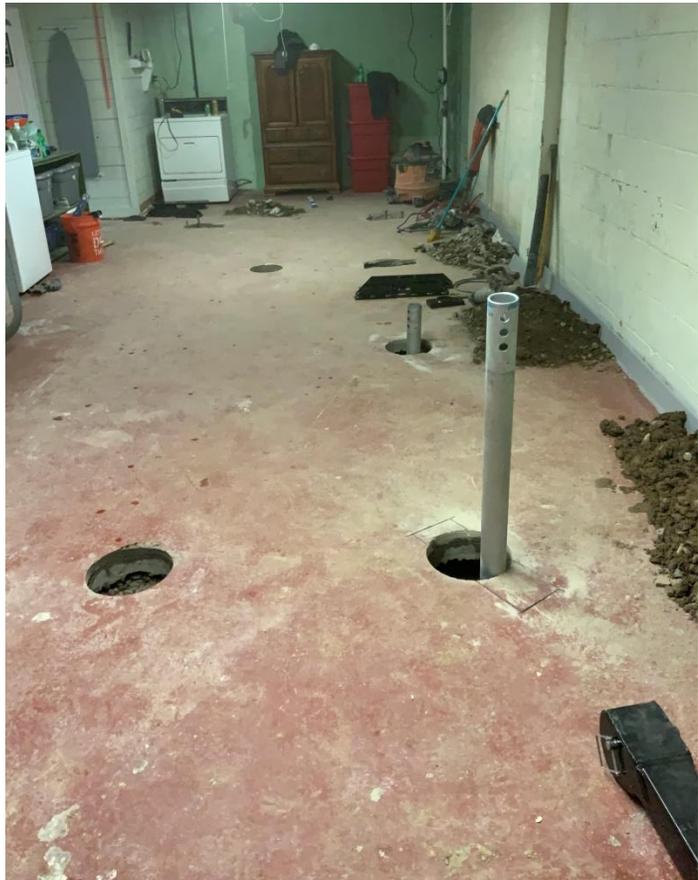
Midstate Basement Authorities was contacted in regards to a water intrusion issue, and were soon to find more than what they initially looking for. Upon creating a small hole in the slab a void was found below the floor extending throughout a significant portion of the basement. A revised plan was made with the assistance of SafeBasements, and a local engineer from Taitem Engineering, to install a system to support the floor consisting of helical piers and polyurethane.
