CASE HISTORY

SAFEBASE™ PUSH PIERS & POLYURETHANE

SLAB PIERS – VOLGA, SD

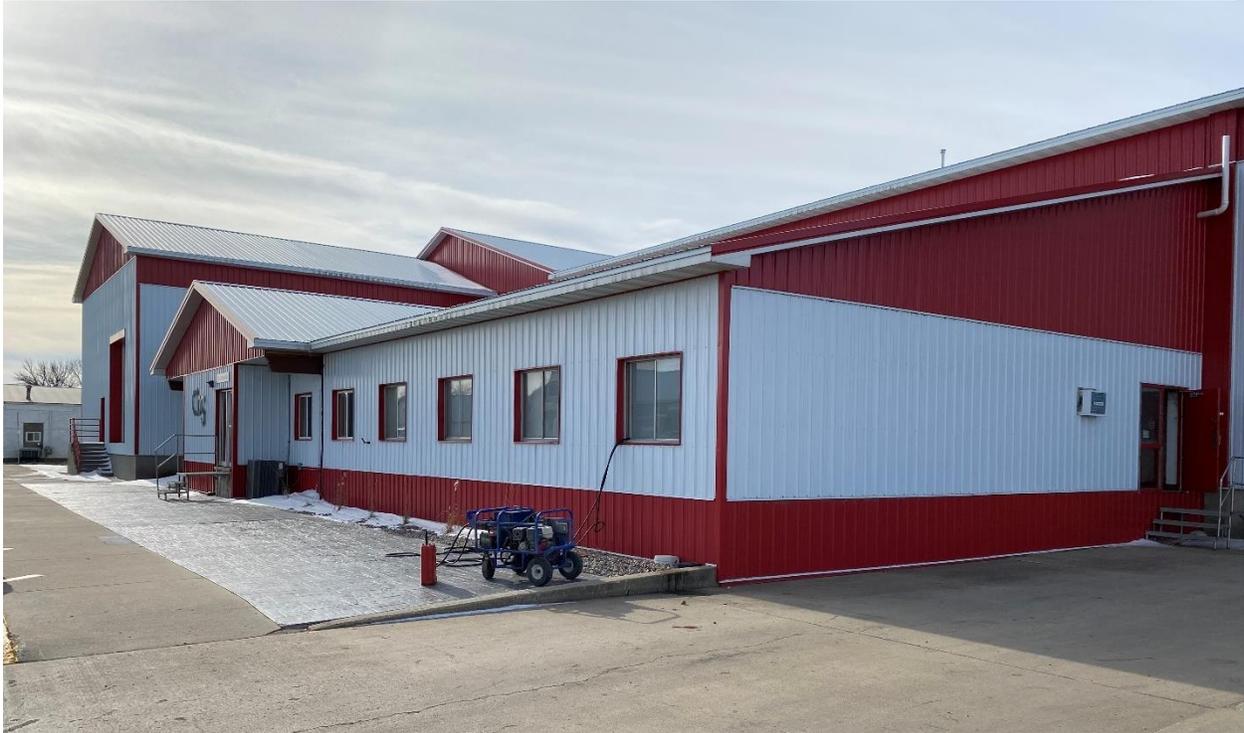
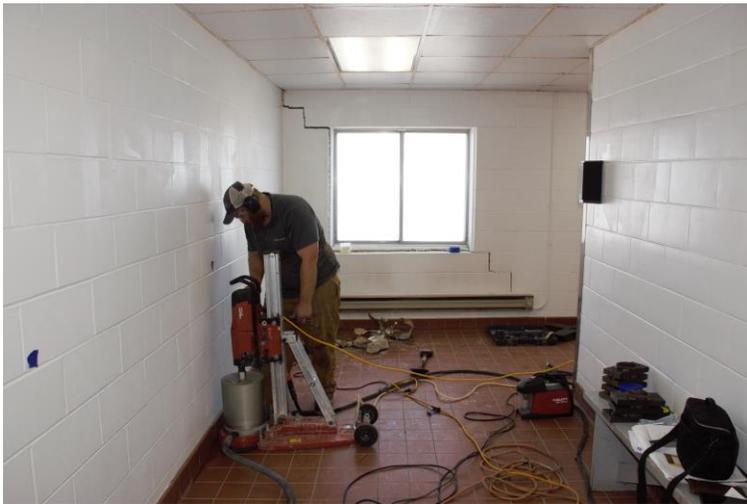
SafeBasements of Minnesota was contacted regarding several issues with sloping floors and cracking masonry walls in the CBS Bio Platforms building in Volga, SD. One corner of the slab was found to be

down approximately 3 inches. There was an interior masonry wall built on top of the slab inside of a second exterior wall. A plan was made to lift the slab and interior masonry wall back into place using a system of slab piers and polyurethane foam. First a series of 10" holes were core drilled along the area to be lifted approximately 6' on center. Then a pocket beneath the slab is to be excavated approximately 2' around to accept the slab 'T' bracket.

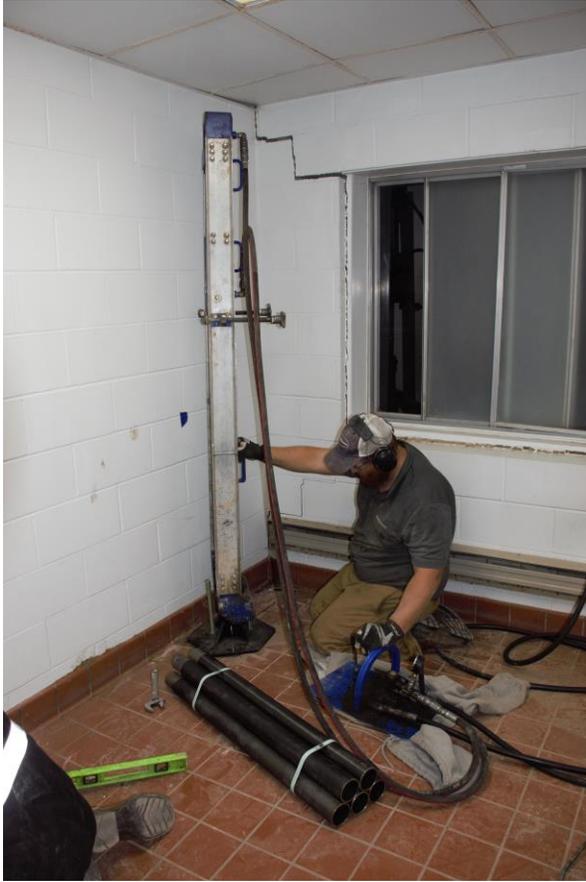
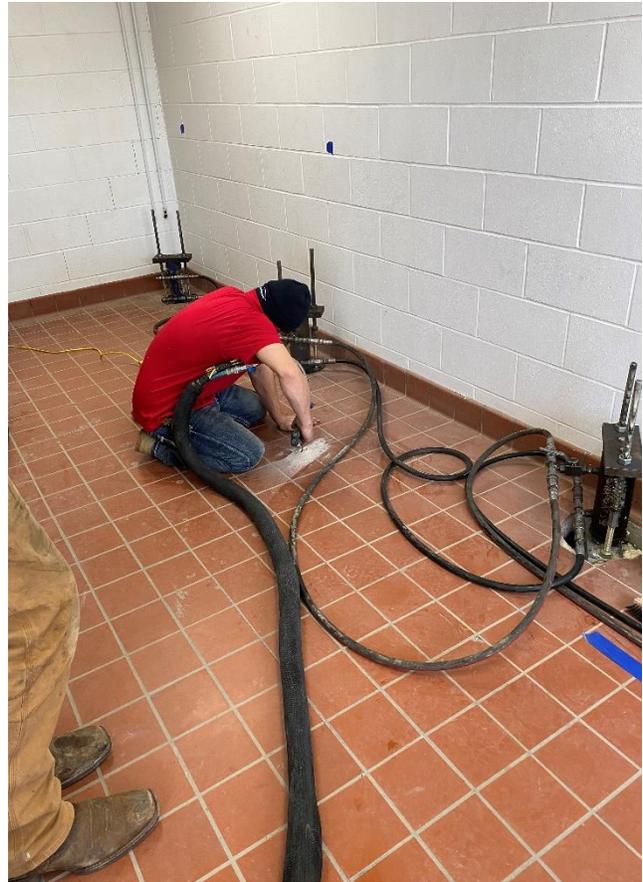
Upon removal of the floor it was found that an abandoned transit heat system was directedly beneath the slab in the location of the piers. The old heat ducts were constructed from 12" cardboard tubes encased in concrete. It was found that portions of the heat ducts were compromised, causing the soil to fill the void space where the ducts were, in turn causing settlement of the slab and walls. Once the brackets were installed a drive adapter was mounted to the top of the bracket connected with threaded rod and the a-frame could be attached to hydraulically drive the push piers. After driving each pier a series of hydraulic lift cylinders were attached to the top of the brackets. While lifting with the hydraulic cylinders polyurethane foam was injected beneath the slab filling any voids created during the lift. The holes for the brackets and the abandoned transit heat ducts also were filled. During the lift cracks in the mortar joints of the masonry wall closed up, and the floor was brought back to level. A total of 9 slab piers and approximately 300 lbs of polyurethane were used. This project was completed in November of 2022.
