CASE HISTORY

SAFEBASE™ CARBON FIBER STRAPS

GRAIN BIN FOUNDATIONS REPAIRED USING CARBON FIBER

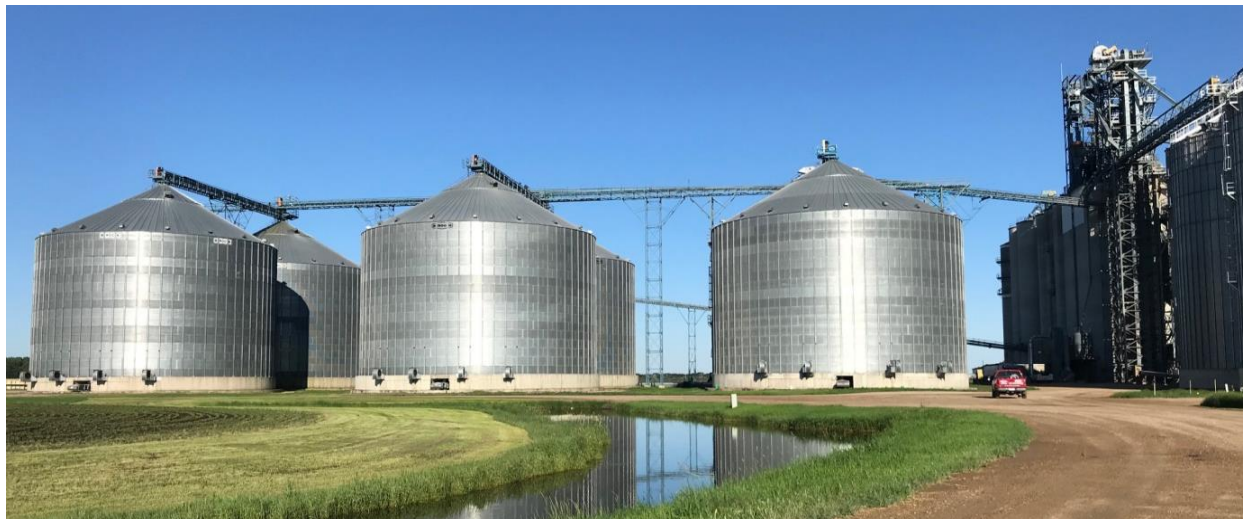
SafeBasements of Minnesota was contacted by Rhino Carbon Fiber with a request from Agtegra Cooperative for foundation repair at their Grebner facility. There were several locations along the grain bins that had areas of concrete spalling at the stiffeners. Two of the six bins had a new concrete walls poured around the perimeter. The other four bins had not been repaired, and recommendations were made to patch the spalling areas and reinforce with 2' wide bidirectional carbon fiber mesh. Approximately 30 locations throughout the four bins had more severe spalling. Agtegra chose to patch the sections and not to wrap the full perimeter of the bins.

Areas on the stem walls were prepared by grinding the concrete 2' down from the top of the wall in sections varying from 10 to 30 feet in length, based on the location of the spalling. The spalling areas were then cleaned and patched with a high strength quick setting weather resistant repair mortar.

Carbon fiber straps were epoxied to the walls in minimum lengths of 10 feet across each spalling section, going approximately 5 feet on each side. A total of 600 square feet of the Rhino Carbon Fiber 2' wide bidirectional mesh was installed on the bins.
