CASE HISTORY

Engineered Floor Supported by SafeBaseTM Class 178 Helical Piers

Minneapolis, MN

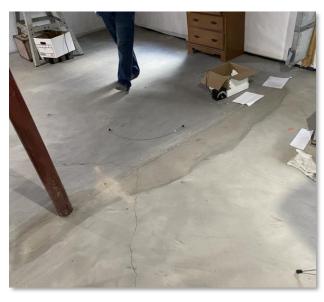
as best as they could, then pouring a skim coat over the existing floor. Within two years the floor had settled about 2-3 inches and began breaking in several locations.
